**Project: 20180004**

**Item description:** SCR-HEX-ISO4014-10.9-(ZFSHL)-M10X40

## **Investigation report**

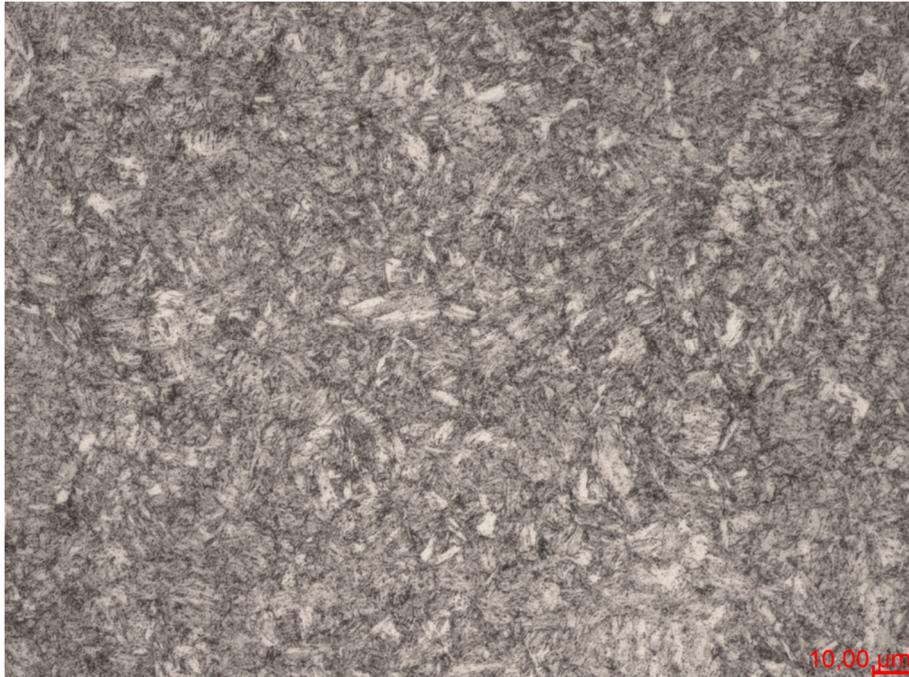
Figure 1: Core area, on shank, sample 4, cross section, etched with 3% HNO<sub>3</sub>, Zeiss Axio Imager/500x

The microstructure contains approx. 90% martensite (see figure 1).

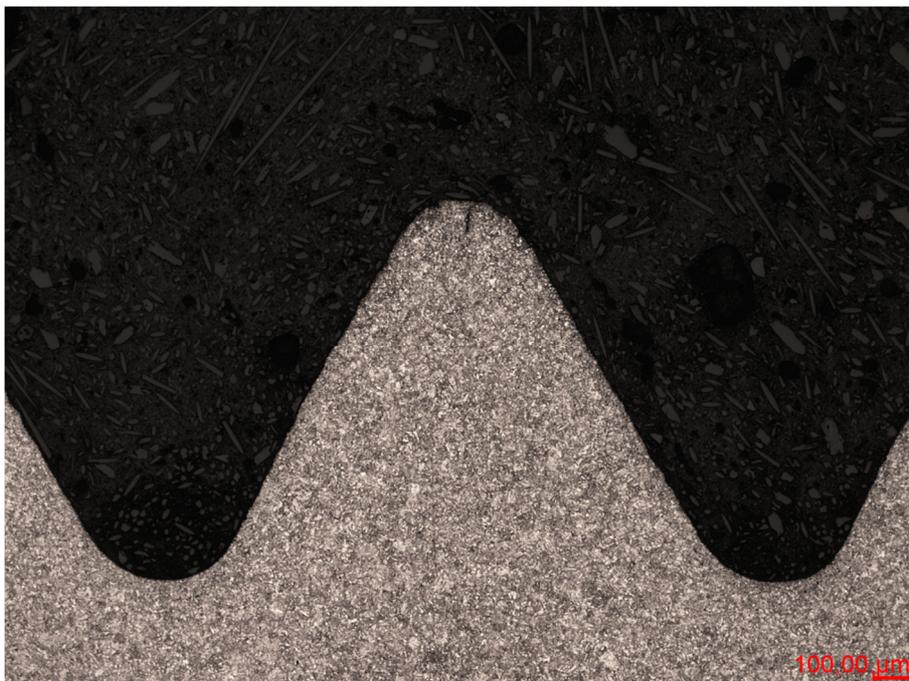
Figure 2: Border area, on thread, sample 4, longitudinal section, etched with 3% HNO<sub>3</sub>, Zeiss Axio Imager/50x

No de- or carburization was found (see figure 2).

No laps were detected on the thread (see figure 2).
